PROJECT OF THE YEAR: INDUSTRIAL COLLABORATIVE

SCALING CALIFORNIA'S CELEGRITS

Skyline Scaffold recently provided complex access systems for the Cedar Creek and Pyramid Dam spillways, facilitating essential maintenance and modernization efforts. **SA** reports.

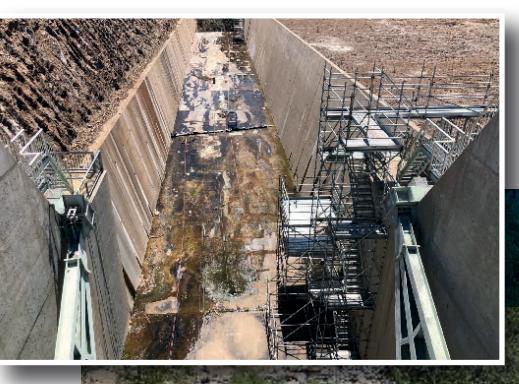
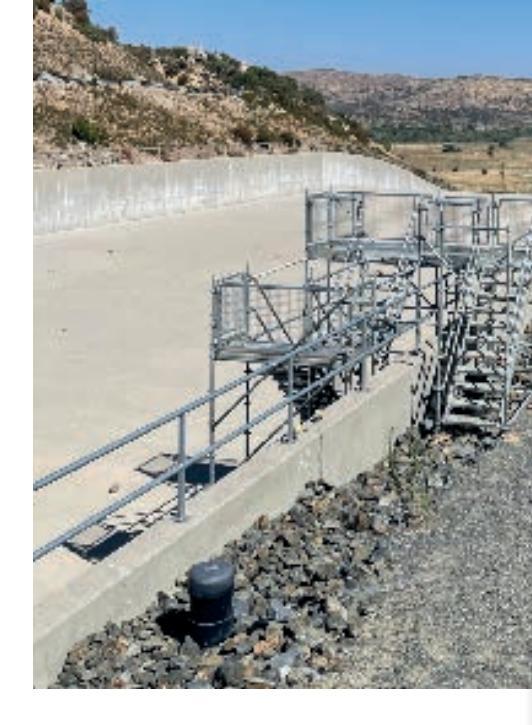
Fast forward to 2023, and SkyLine Scaffold was back on site to provide all necessary access and working platforms for the spillway repair. This included stair towers inside and

outside the spillways, an 11-meter inclined suspended scaffold with a 600-foot drop at a steep angle, and observation and mobile towers for the spillway.

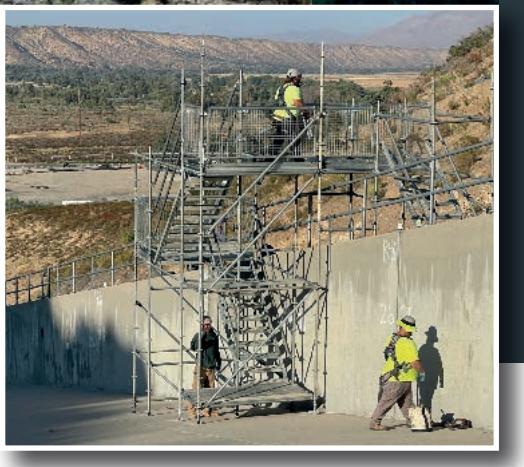
INSET: The Pyramid Dam spillway. BELOW: Walking stairs and the creek bridge at the bottom of the dam's spillway.

Additionally, SkyLine provided walkways to access the uneven terrain and bridges over creeks so the project team could get to the locations they needed without additional fears of rattlesnakes and other hazards.
